Kostas Zambas, Civil Engineer, Dr. National Polytechnic School, 43 Skiathou St., 11254 Athens.

Athens Feb. 26, 2015

Subject: Restoration studies and works of the ancient theater of Megalopolis (The Greatest Theater in Greece, according to Pausanias, VIII, 32, 1).

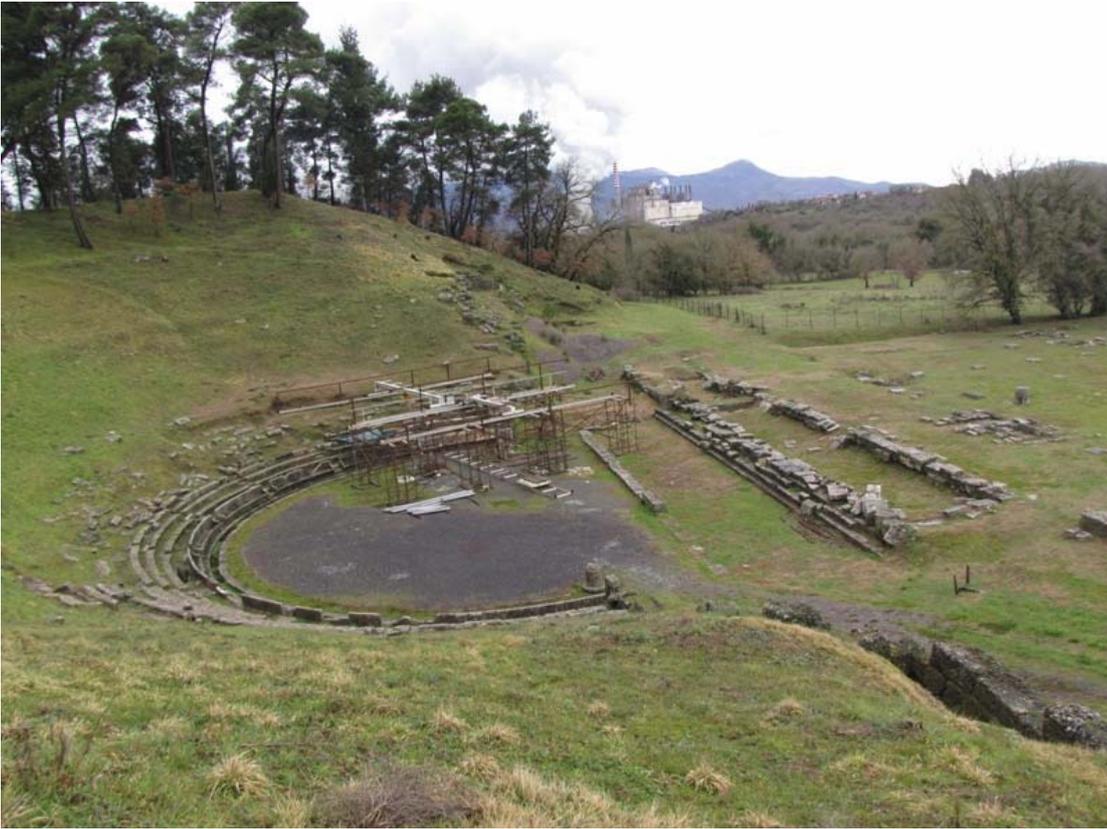
Image 3. General view of the theater from SE. Visible is the overhead crane at the western edge of the orchestra.

Based on the approvals, there have been works in several phases starting with most important being the embankment at the area of the lanes with large volumes of gravel in order to support the crumbly retaining walls⁴. This was followed by an intervention in the upper half of the eastern retaining wall, cleaning and restoring of stone parts, deforestation of vegetation, restoration of the lower rows of the Theta (Θ) tier (extreme west)⁵, while in the area there are worksite facilities with a scaffolding and crane at the orchestra, two worksite huts, a shelter etc. (images 3, 4).

For the works at the lower part of the auditorium, the existing overhead crane can be used, after cleaning and painting the parts of the scaffolding that have rusted. Turning the whole system to the east is possible with the help of a crane. It is also possible to add a light aluminum overhead crane for lighter weights.

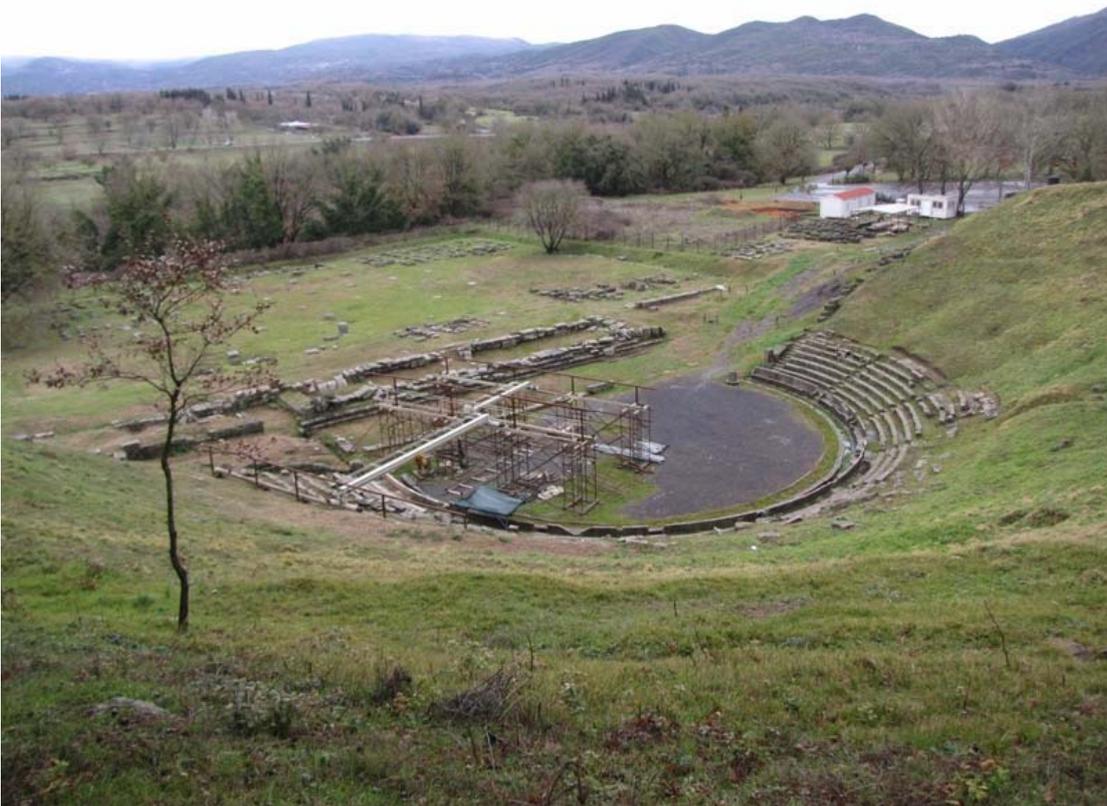
Image 4. General view of the theater from SW. Visible in the background are the worksite huts and the shelter.

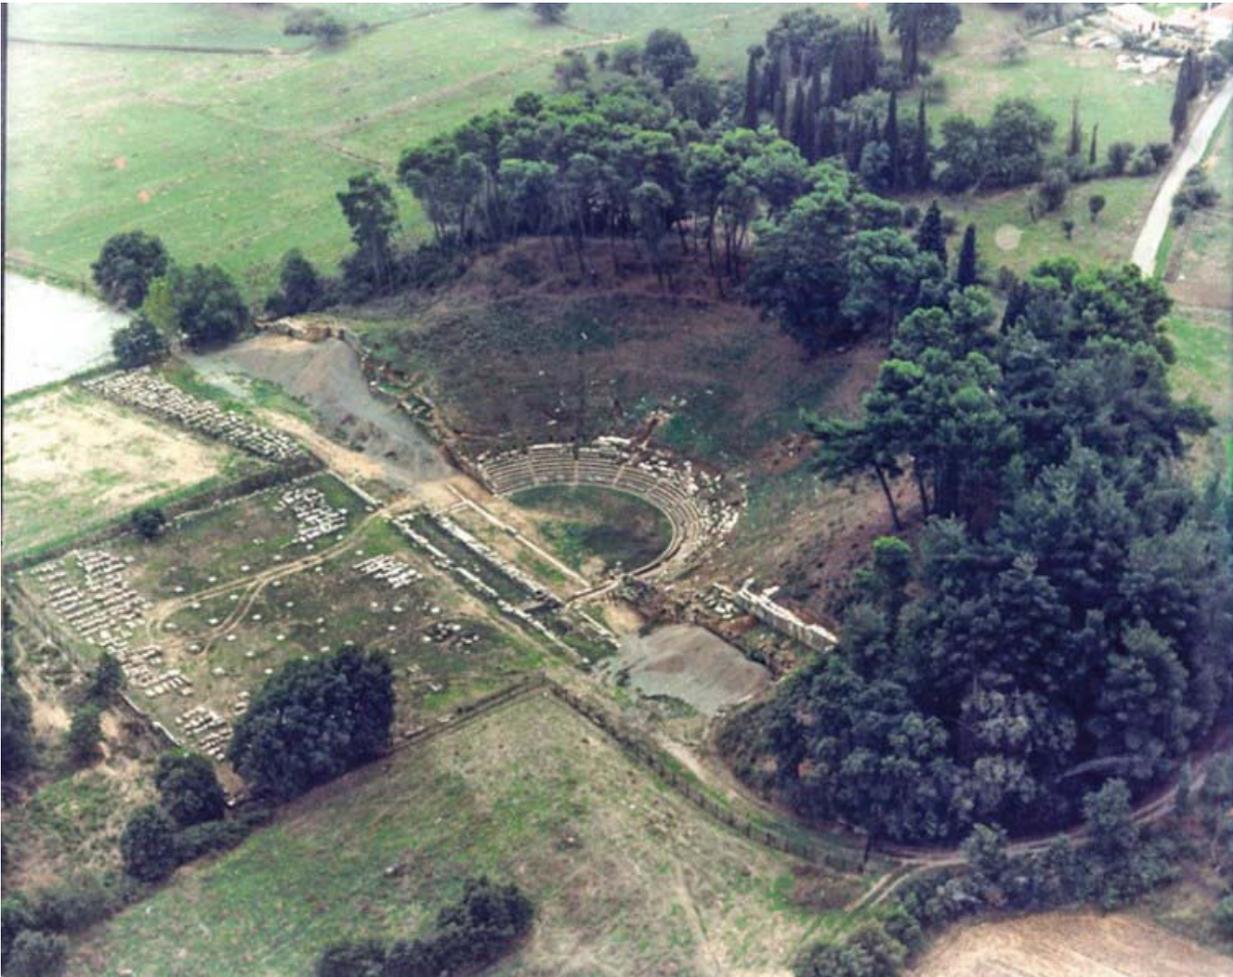
In the eastern retaining wall, back-fillings of gravel that were used to brace it (image 5) had replaced the earlier wooden struts (image 6). Backfilling was removed from the upper half across the retaining

Image 5. General view of the theater with the earth fills for the protection of the retaining walls (c. 1999 before the intervention) <http://www.diakopes.gr/destinations/peloponnisos/arkadia/megalopoli/?cid=43924>

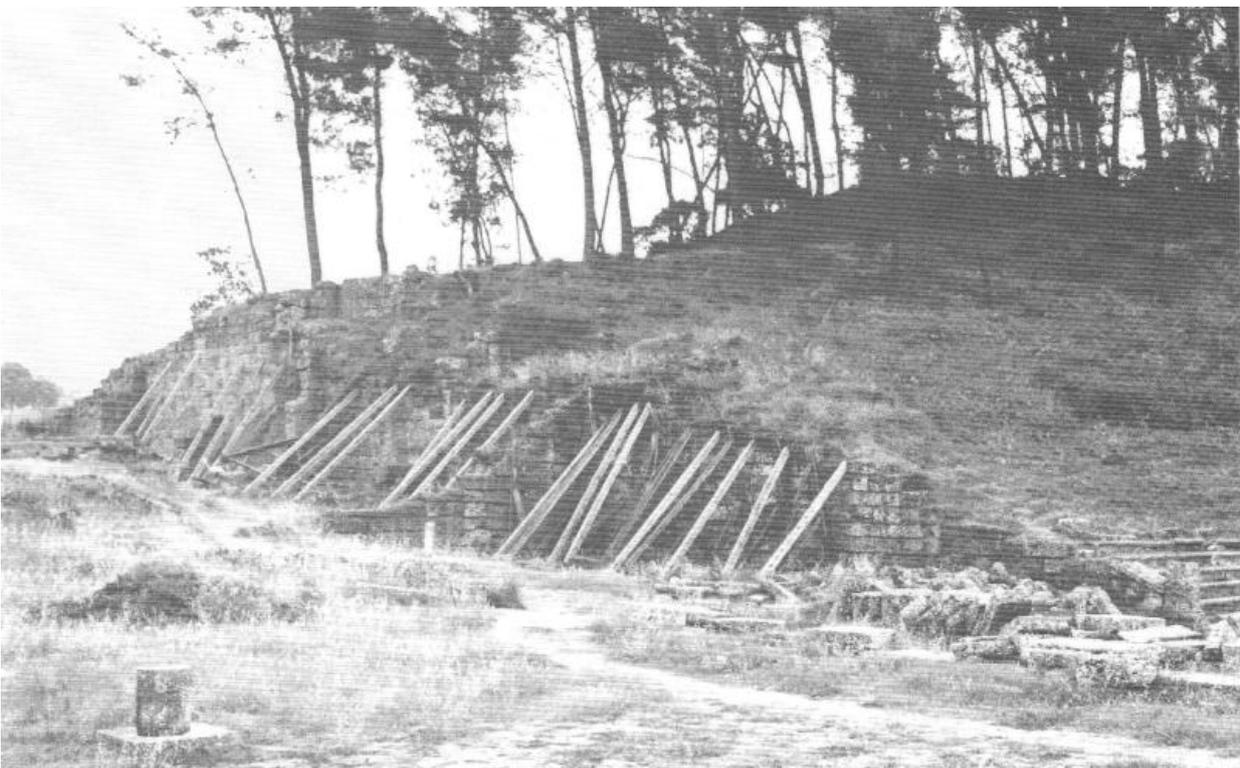
Image 6. The eastern retaining wall with the struts before the earth fills (Portelanos, Kambourakis 1993, 49).

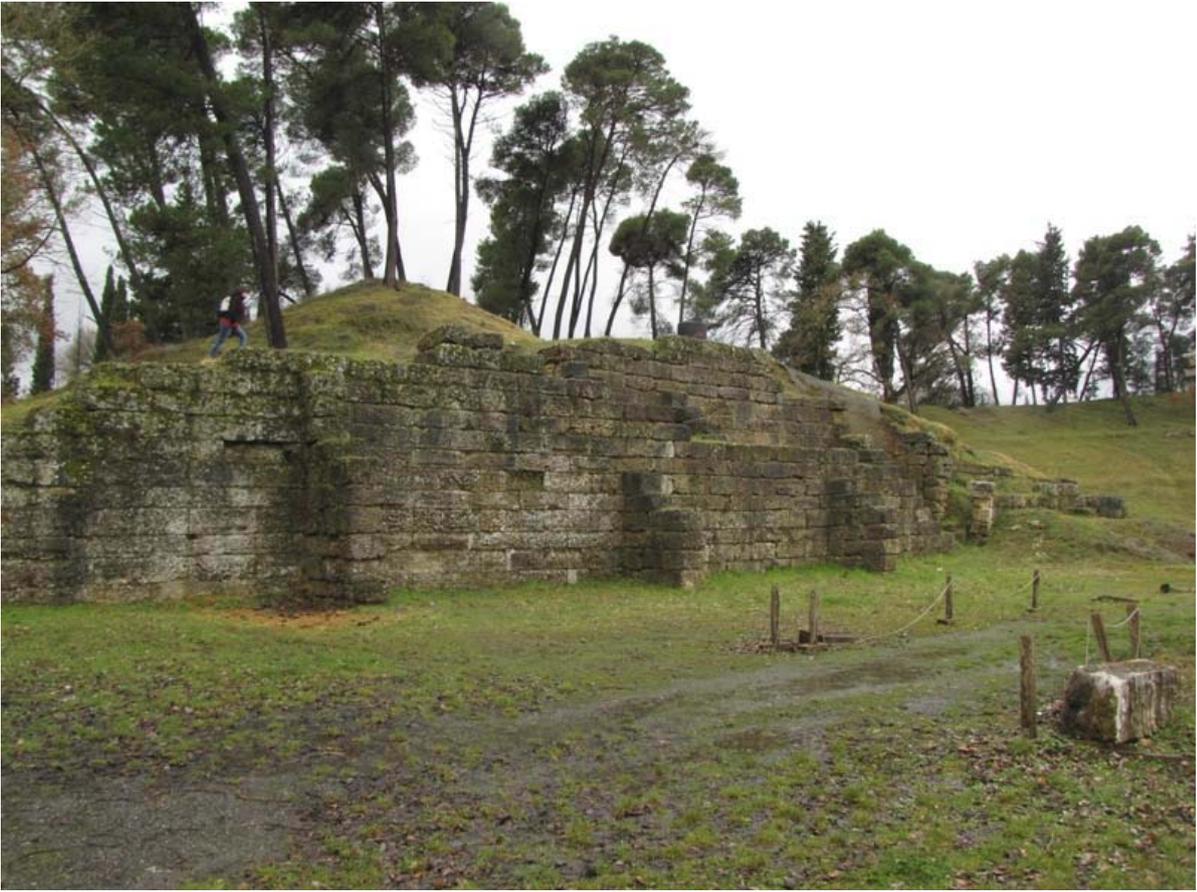
wall, and mounting works were executed. Comparing the current situation (images 7-9) to that imprinted by Portelanos-Kambourakis shows that many of the blocks of conglomerate and breccia rocks that had collapsed in 1996⁶ are still today orderly placed on the ground north of the retaining wall (image 10). In image 11, the shadowed parts on the Portelanos-Kambourakis plan show the fragments of the outer and inner retaining wall which had survived until 1996 and must be now repositioned after finding the original location of each one of them.

Image 7. The upper part of the eastern retaining wall.

Especially in what concerns the disassembled upper part of the eastern section, all available information should be gathered in order to find the initial position of the stone blocks and reposition them.

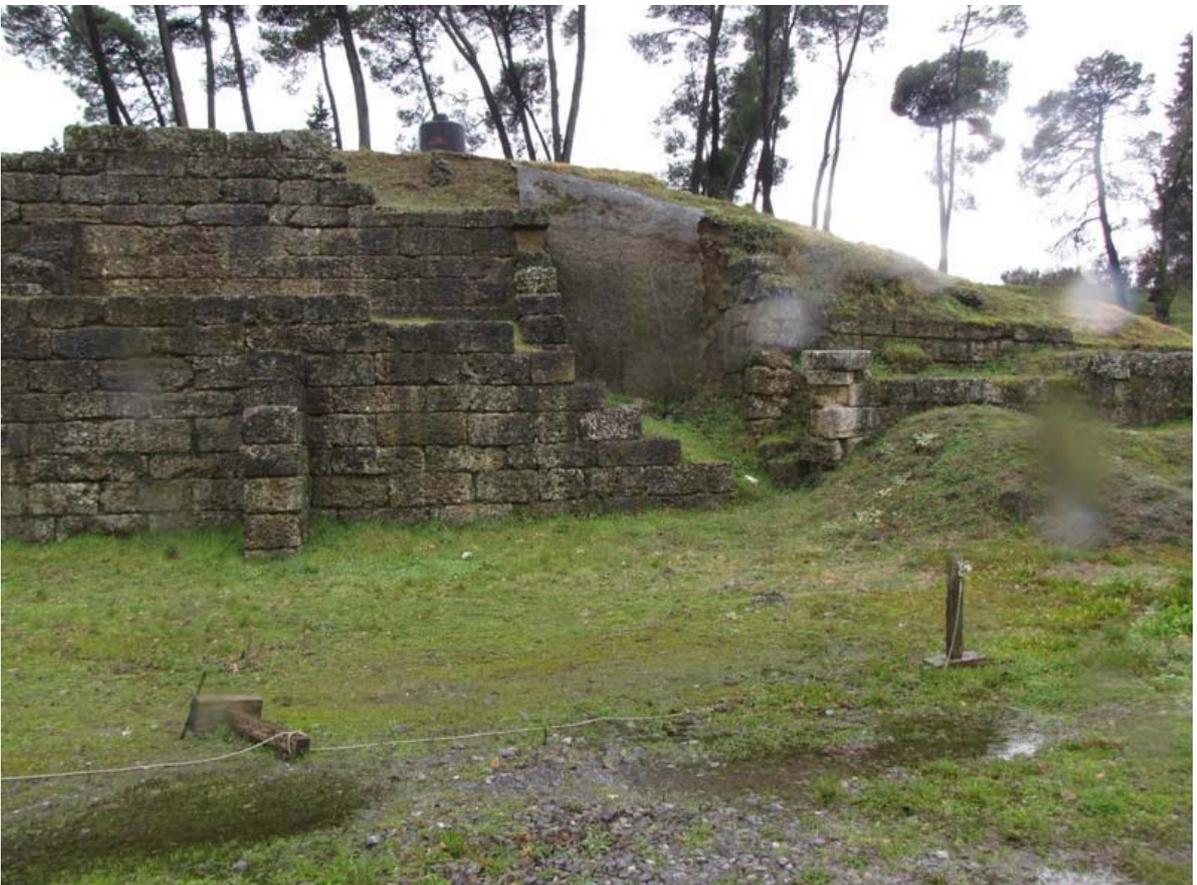
Image 8. The area of the upper part with no upper layers.

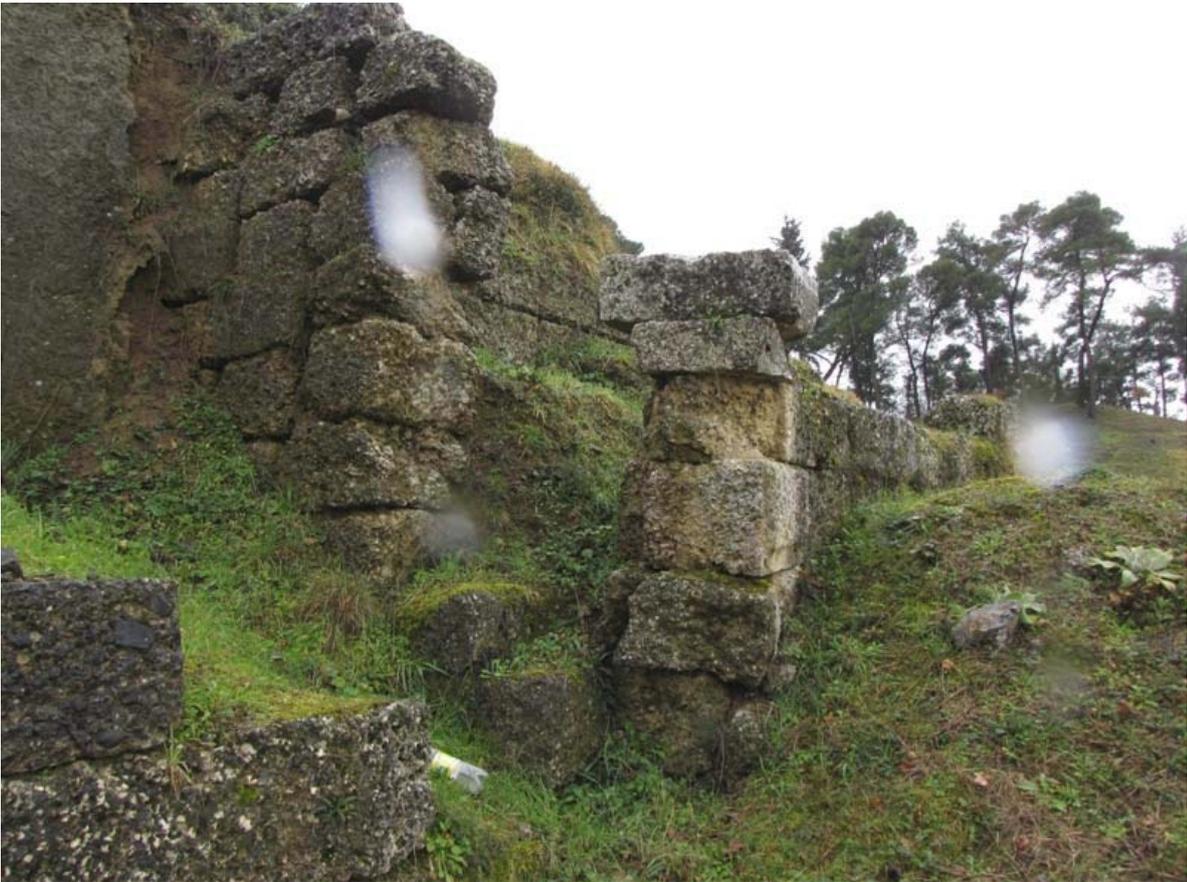
Image 9. Internal transverse wall in ramshackle condition.

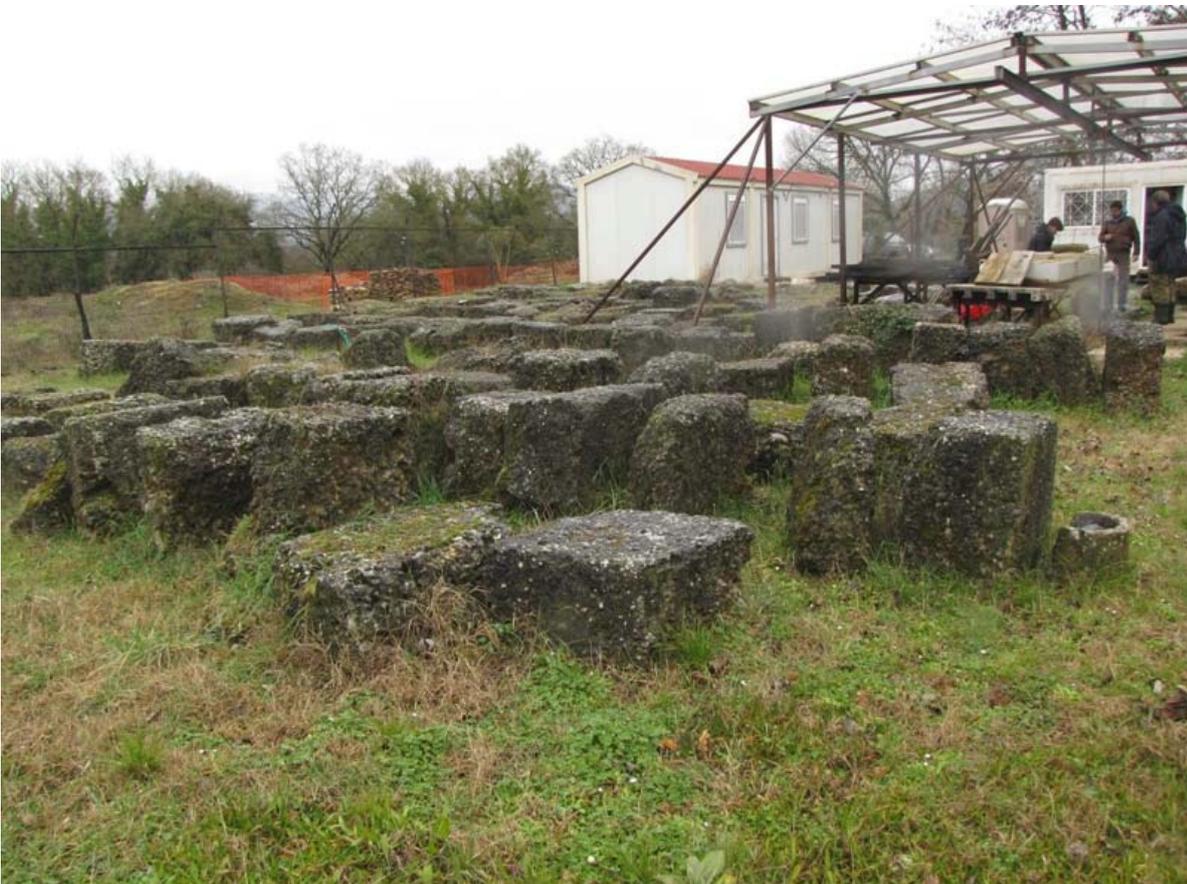
Image 10. Orderly stone plinths of the eastern retaining wall.

Reconnaissance of the position of the stone blocks of the eastern retaining wall that are on the ground and conduct a study for their reinstatement.

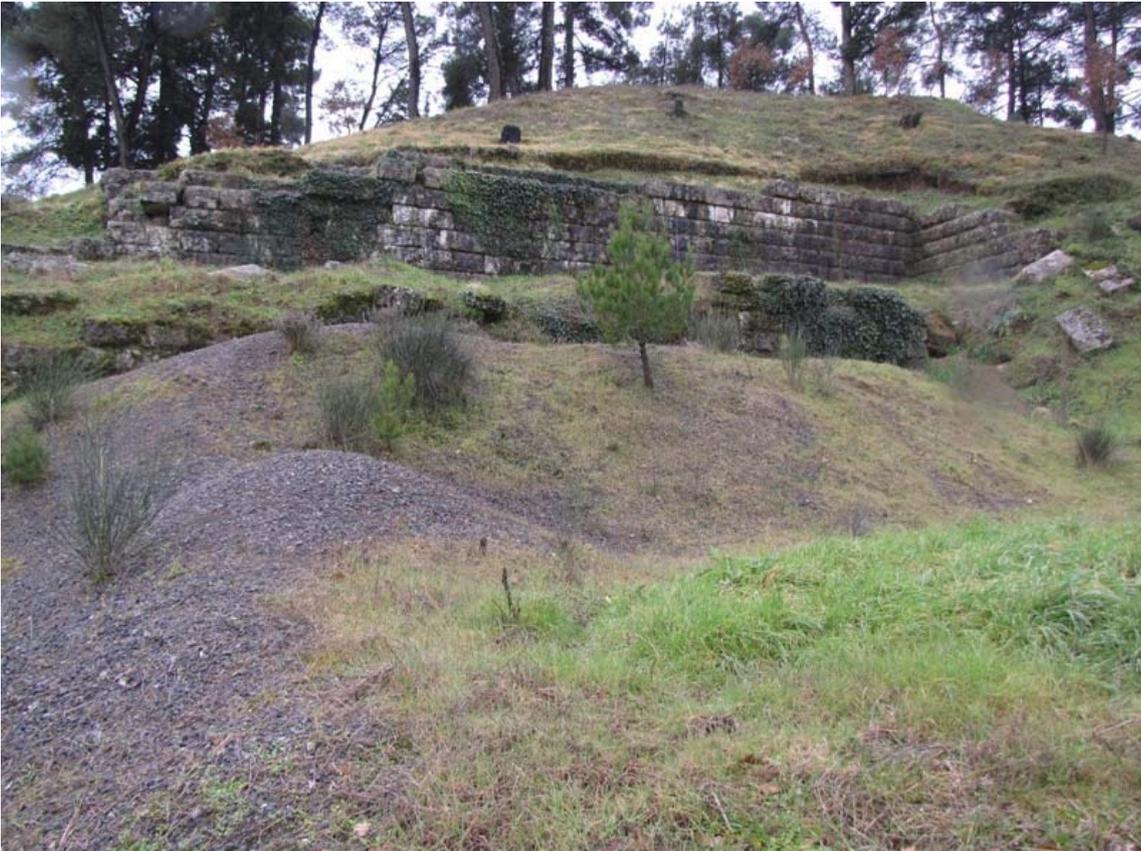
Works have taken place in the western retaining wall. Behind the volumes of gravel that support the retaining walls of the auditorium and the skenotheke (store room in the skene), there are conspicuous large deformations of the walls (images 12, 13).

Image 12. The western retaining walls with the earth fills.

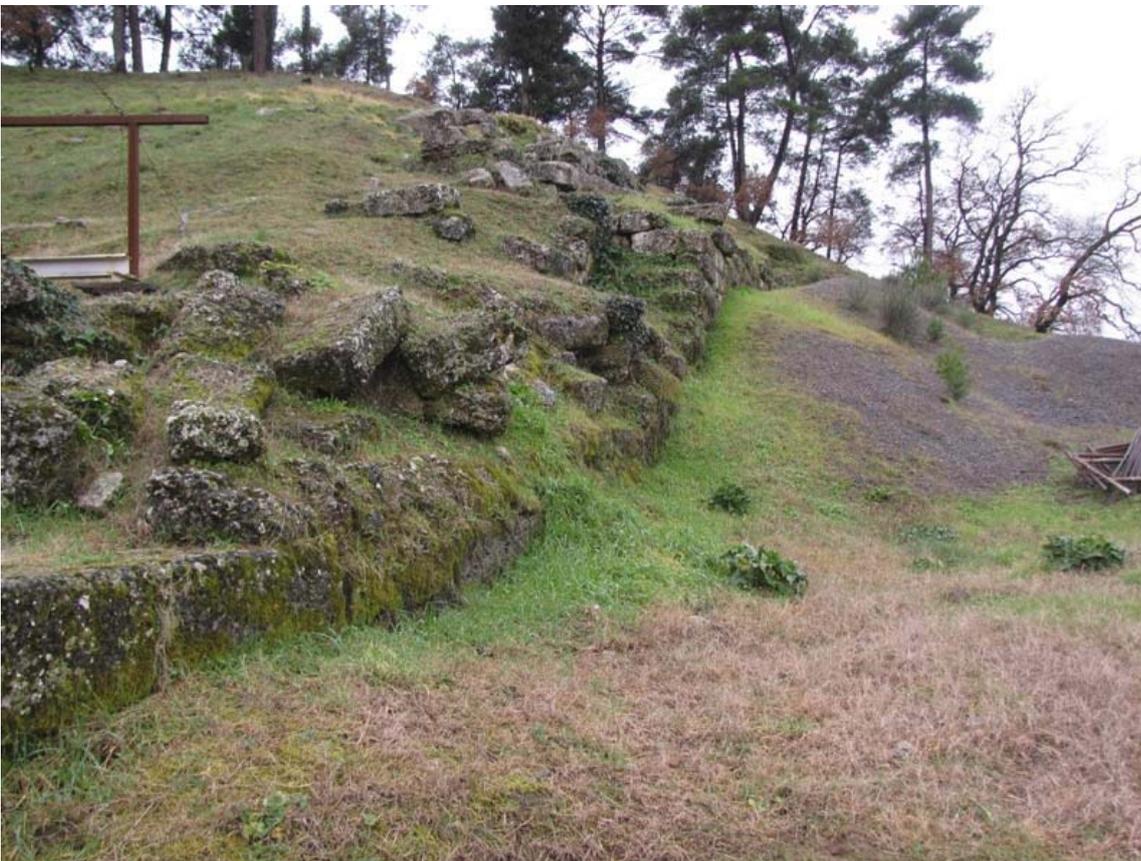
Image 13. The western retaining walls from tier A. Visible are the large deformations.

Our opinion is that we can probably avoid the general dismantling of the retaining walls and restore them by locally dismantling their most deformed parts, restoring some other parts and reinforcing the rest with the use of internal “invisible” structures. In any case it is necessary to plan ahead and monitor closely the excavation works in order to draw the appropriate information and complete intervention proposals. Therefore when we know the actual data from the incisions it is most likely to review the studies that have been carried out already.

Based on the results of the incision research we will define the method of intervention in an implementation study phase, making the best use of studies already carried out.

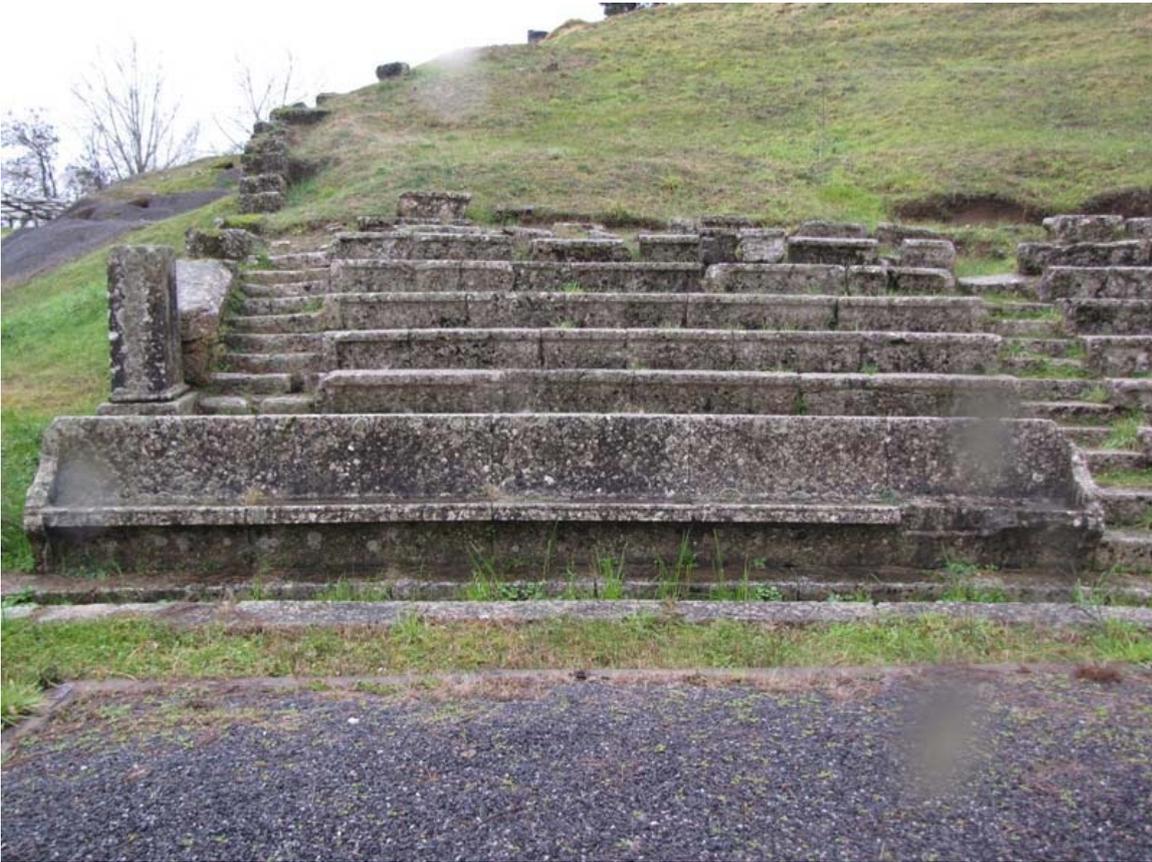
The stone hollow part in the section excavated is preserved in very good condition and with rare completeness (images 14-29). The full row of the proedria (VIP) front seats (images 14-23), the ending of the parapet with wall crown moldings in the east (image 14), the culvert for rainwater drainage, which has been cleaned and is in operation, are all elements of the original form that are rarely kept in such good condition. Restoration works have taken place at the lower rows of the Theta (Θ) tier, where missing stone architectural elements were filled (images 22-27).

Image 14. Tier Alpha (A).

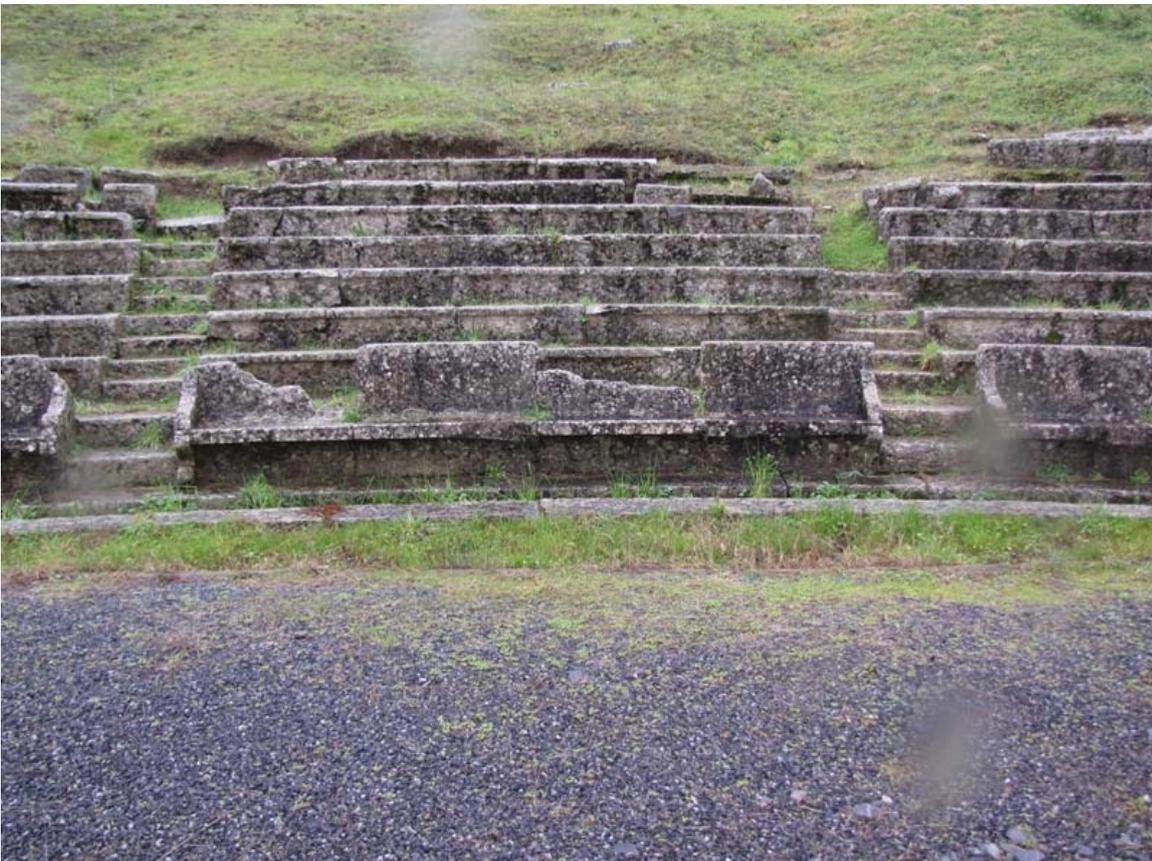
The stone members of the auditorium are preserved up to the 7th row of the Beta (B) tier (image 15), but restoration, repair, and maintenance is required at the seats that have suffered large deformations (images 28, 29). Under the centuries-old earth fills there are probably more members like those disclosed at the lower rows. In a test pit excavation at the extension of the 7th scale between tiers ST and Z (6 to 7) stone members of the upper auditorium (image 30) have been revealed⁷. In other places, large trees (apparently up to 100 years old judging from early 20th century photographs)⁸ have grown strong roots onto the stone members, which are probably under the earth fills (image 31).

Image 15. Tier Beta (B).

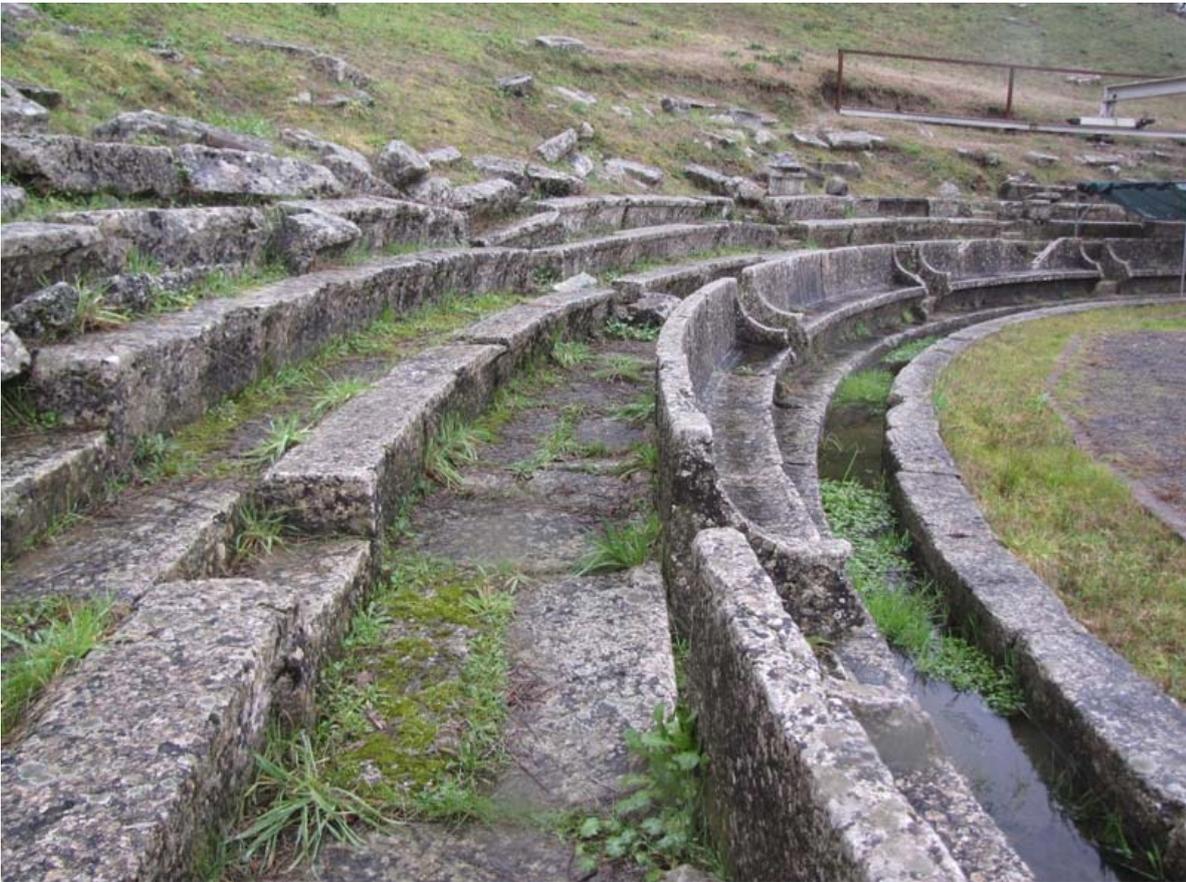
Image 28. The western half of the upper part of the auditorium.

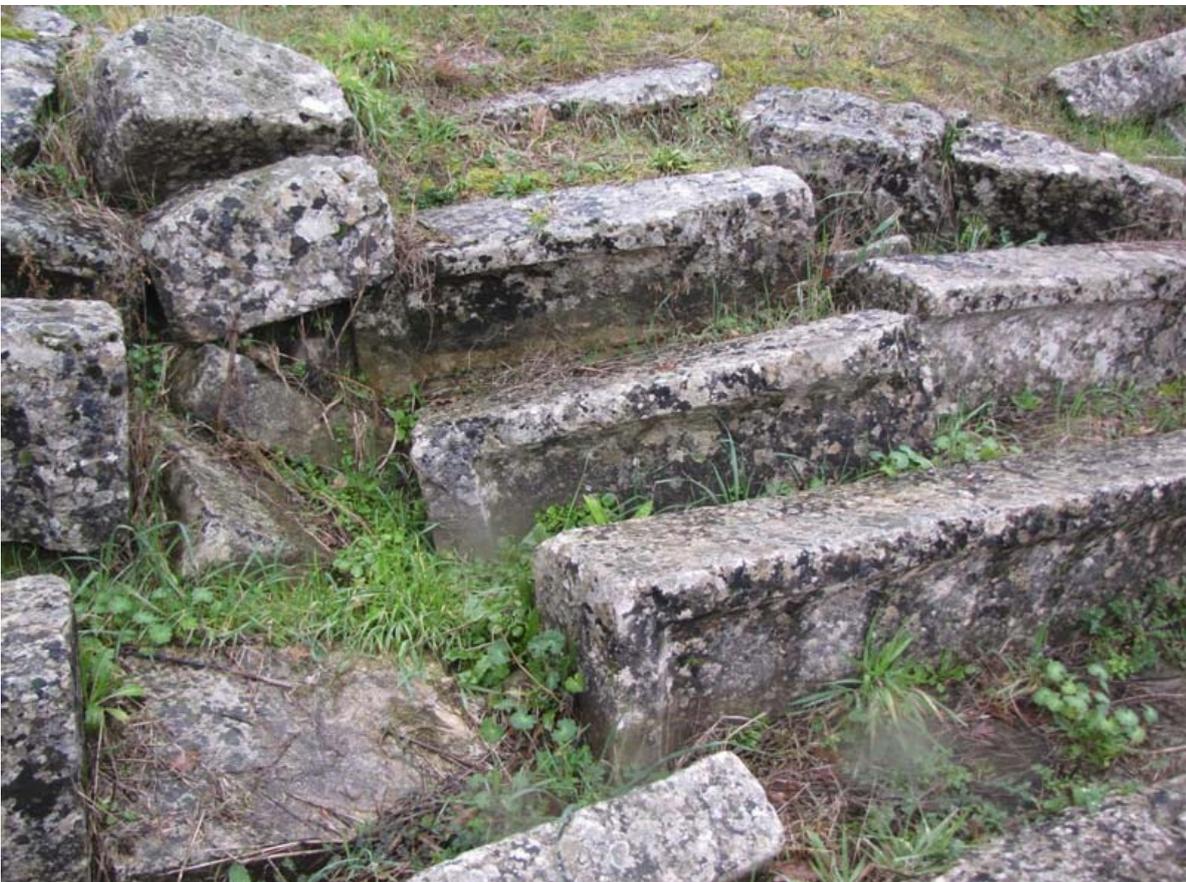
Image 29. Large deformations of benches and stairs in tier Sigma Tau (ΣT).

The first area is defined by the lower rows of the stone auditorium that have been revealed. Work will include restorations, weldings, additions, sealing of stone members. The implementation study will include mapping in a 1/20 scale and all detailed proposals will be submitted based on those designs. It should be mentioned that there must be a complete picture of the works required in all tiers, in order to have a clear overall view of what extent there should be provisions for each type of work, especially regarding the fillings with new material. Our opinion is that the already completed fillings have also included very small pieces, which were not required for reasons of safety, stability or completion of the form.

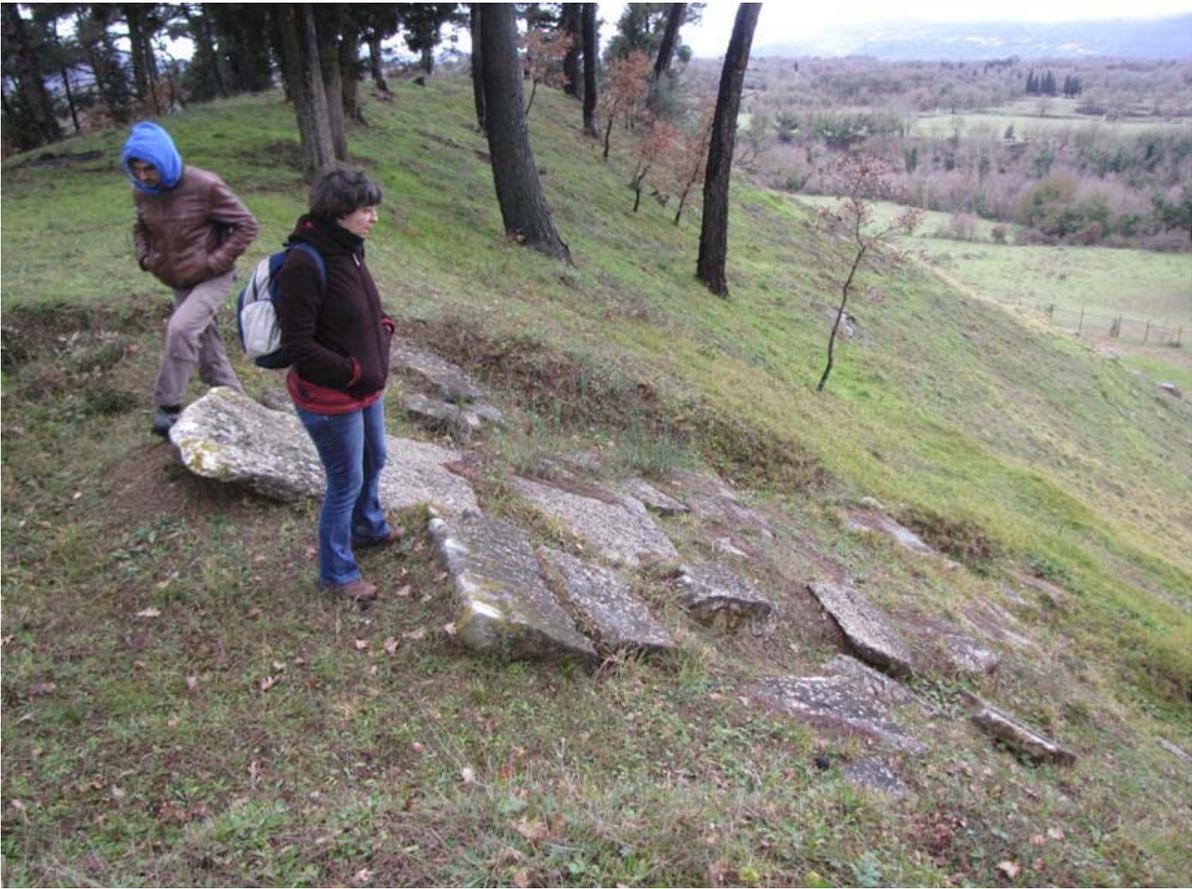
Image 30. Revealed parts of the stone auditorium at its upper edge.

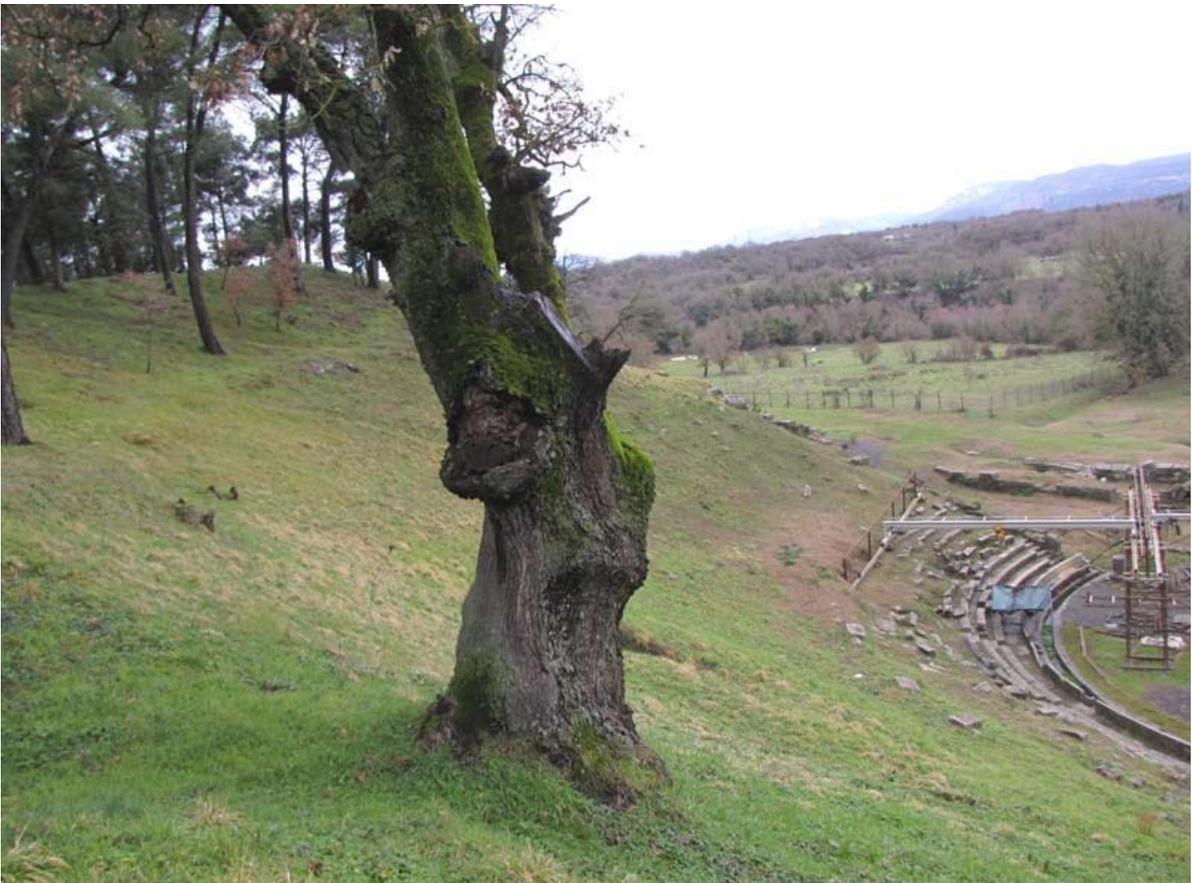
Image 31. Old pine tree in the upper part of the auditorium.

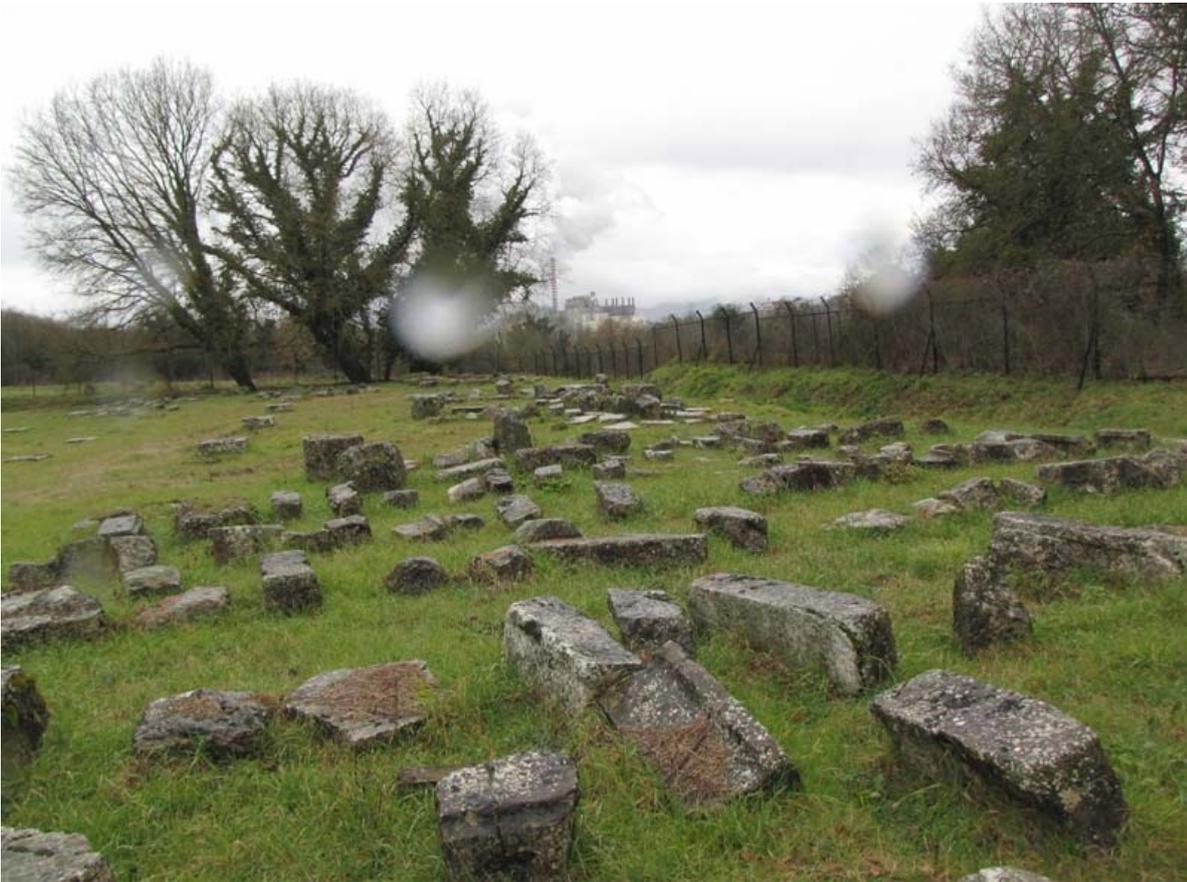
The seats and steps that are currently on the ground in the area of Thersileion (image 32) together with those which are still under the transferred debris of earth fills enable restoration and enhancement of a much larger part of the auditorium. The new stone pieces that already exist at the worksite can be used as additions to the lost parts of the scattered members (image 33).

Image 32. Sorted seats in the Thersileion.

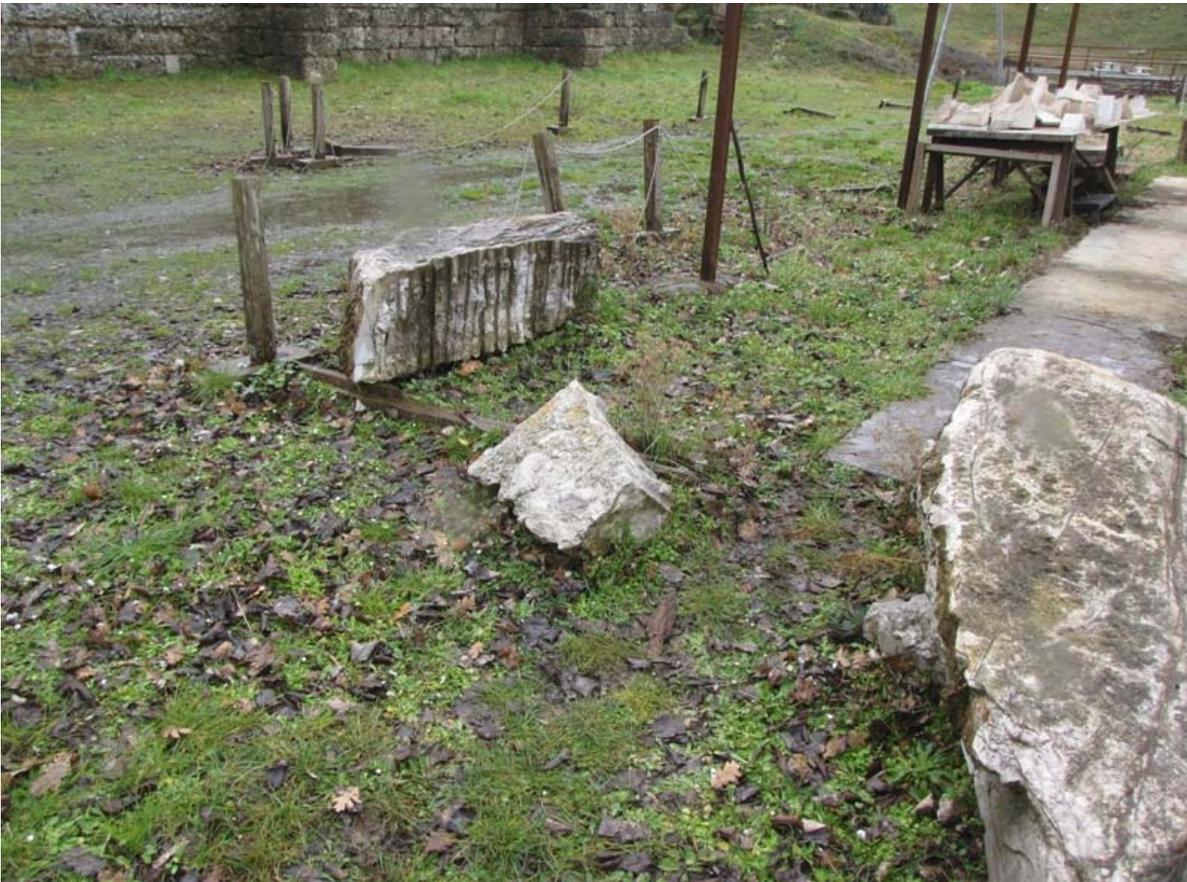
Image 33. New volumes of marble for fillings.

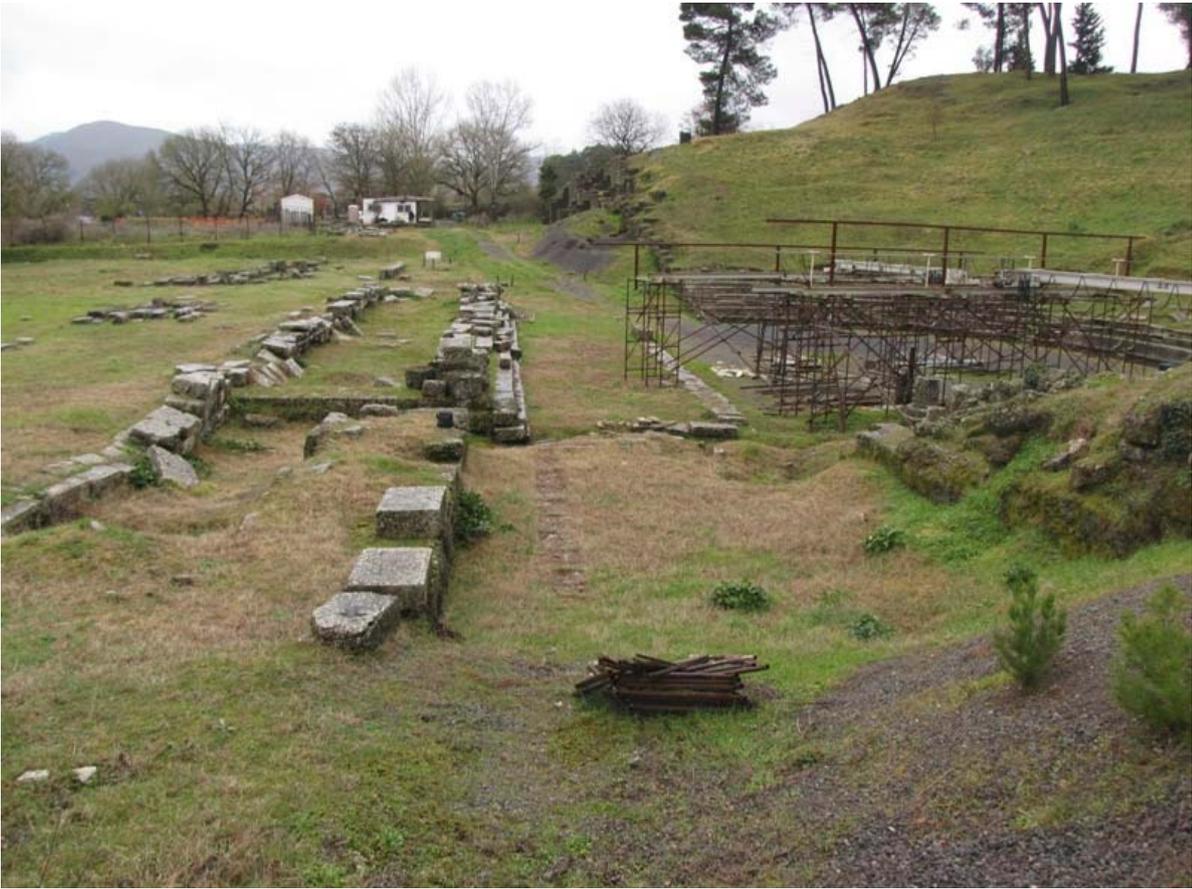
From the crepis of Thersileion (image 34) that of the propylon (portico) is practically undisturbed,

Image 34. General view of the crepis of the Thersileion and its propylon (portico).

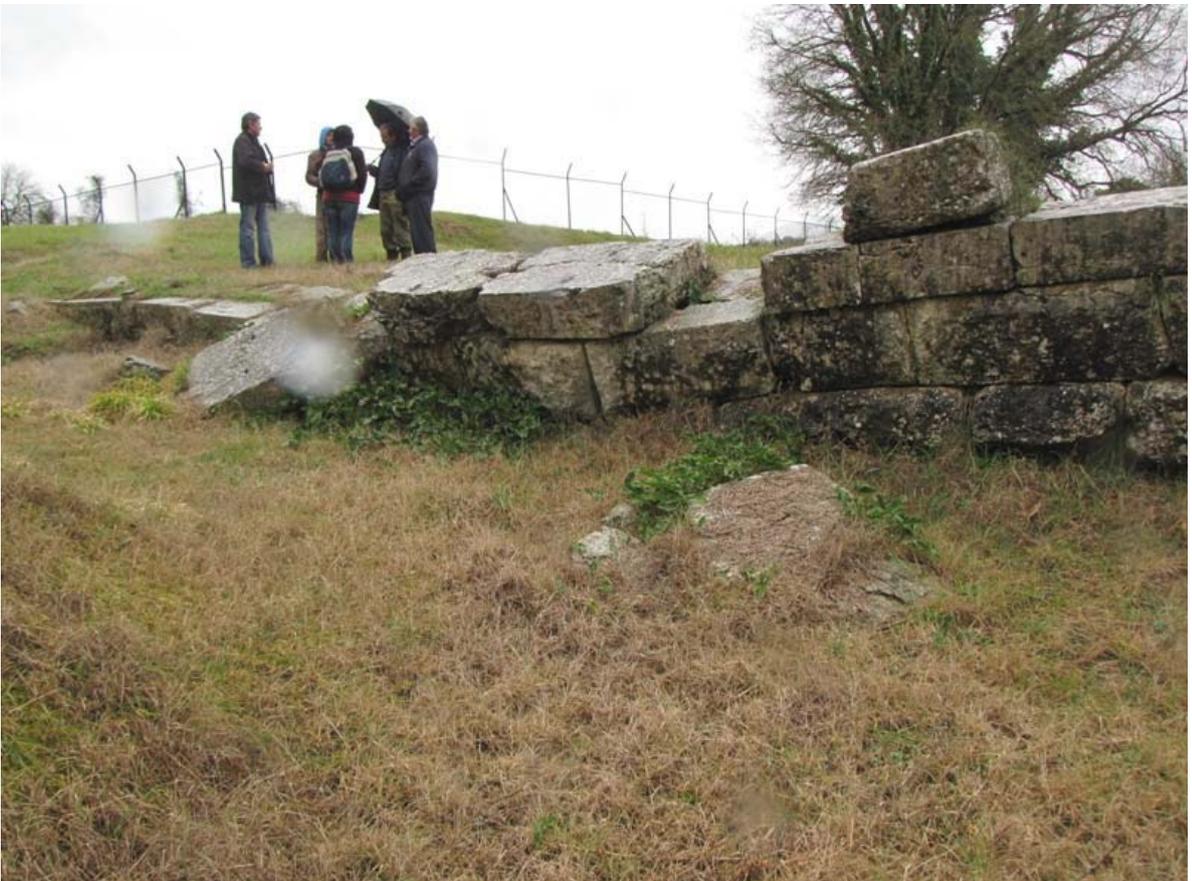
whereas in the west end of the southern wall there can be seen large deformations (image 35).

Image 35. Large deformations in the western edge of the crepis of the Thersileion.

After systematically clearing the site, exploratory incision in the west end of the southern wall and excavation research.
